Failure levels in LNAs

Sam Jewell, G4DDK
EME 2016
Venice, August 2016

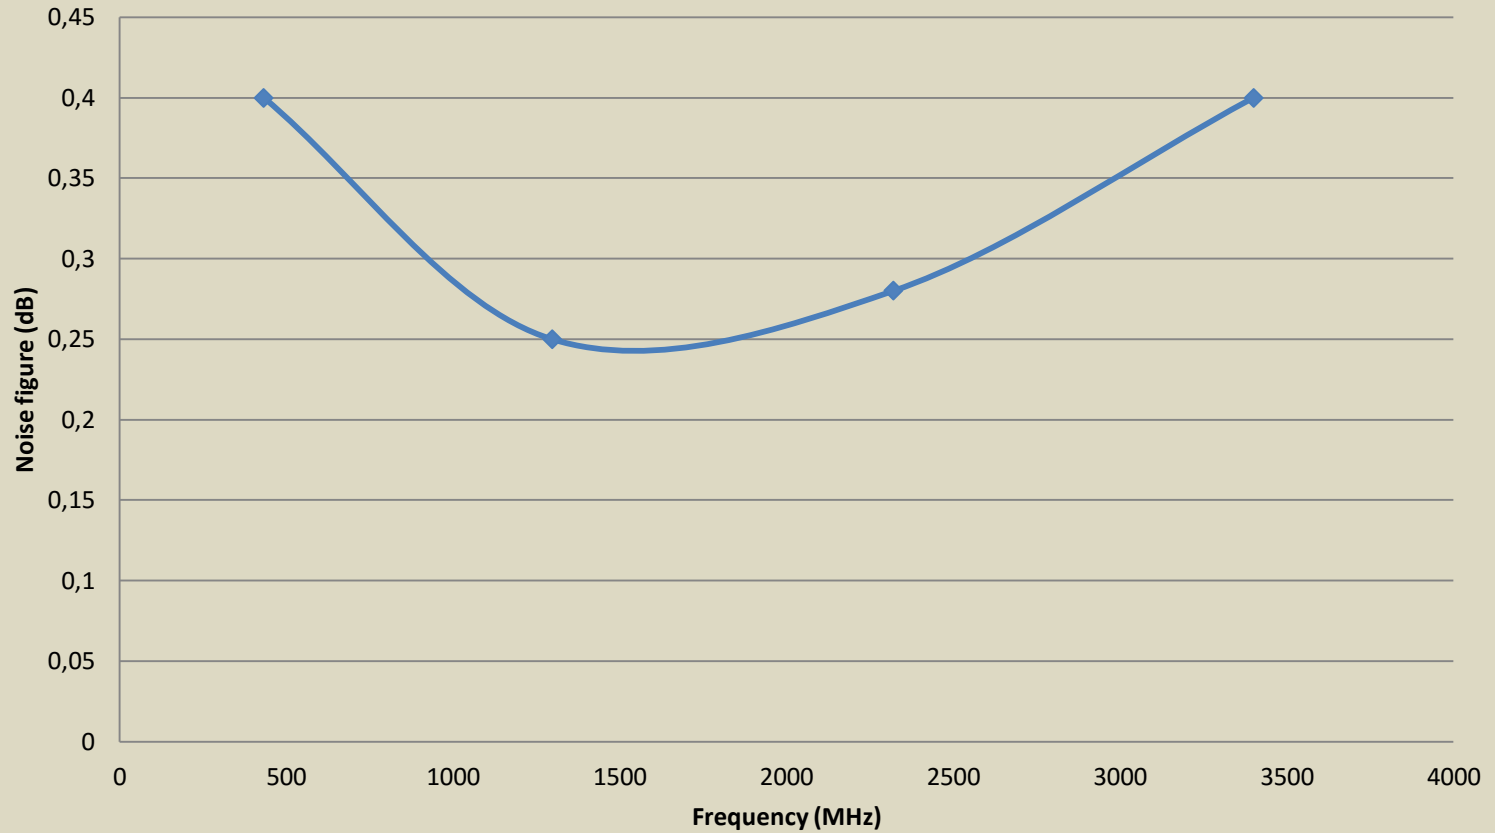
Typical VLNA noise figure

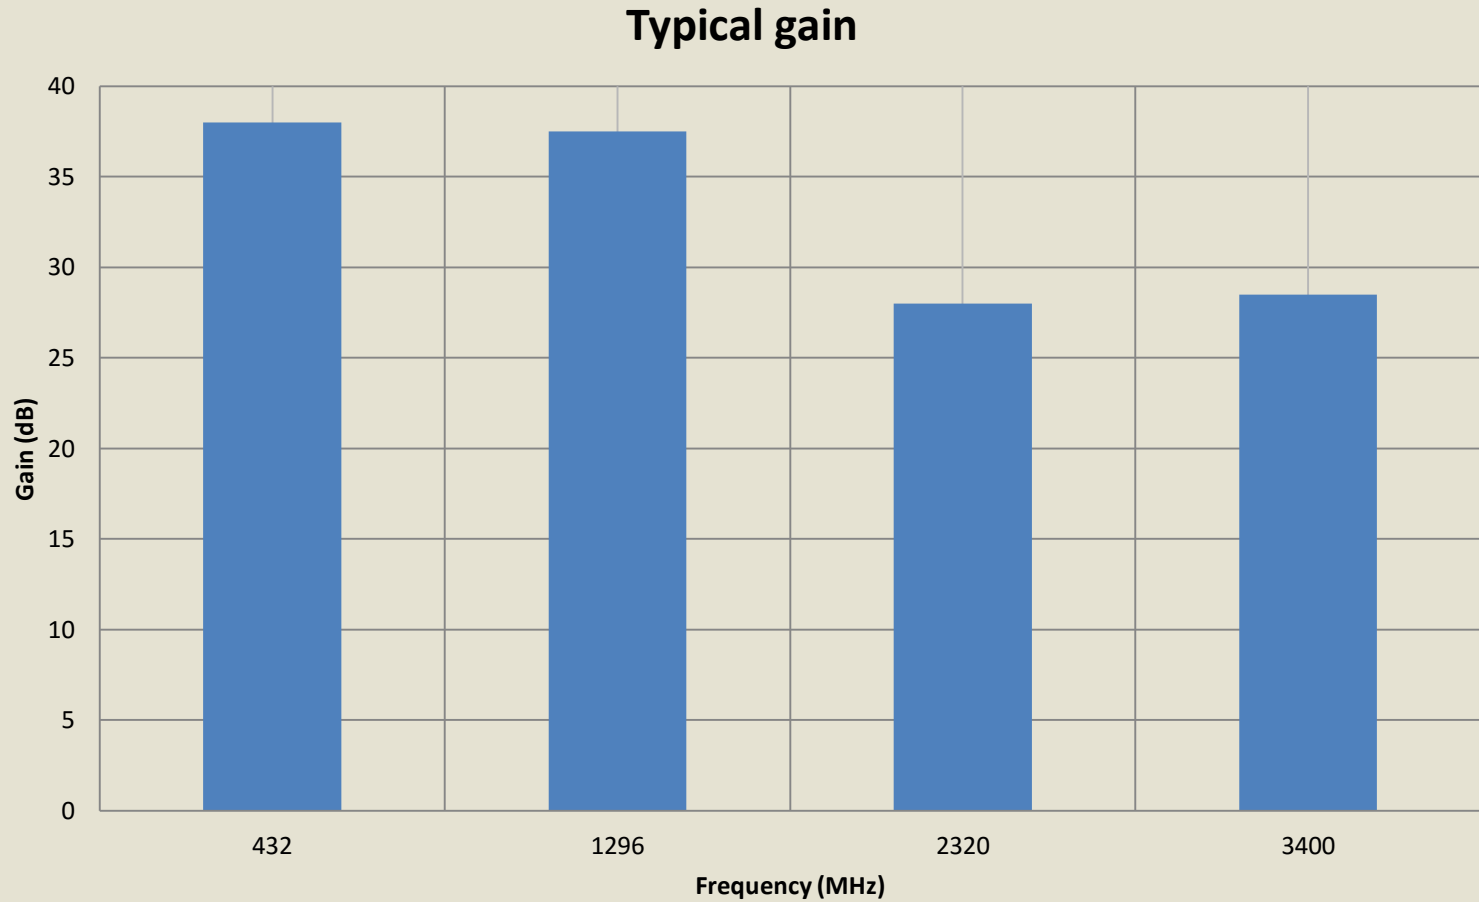
VLNA typical gain

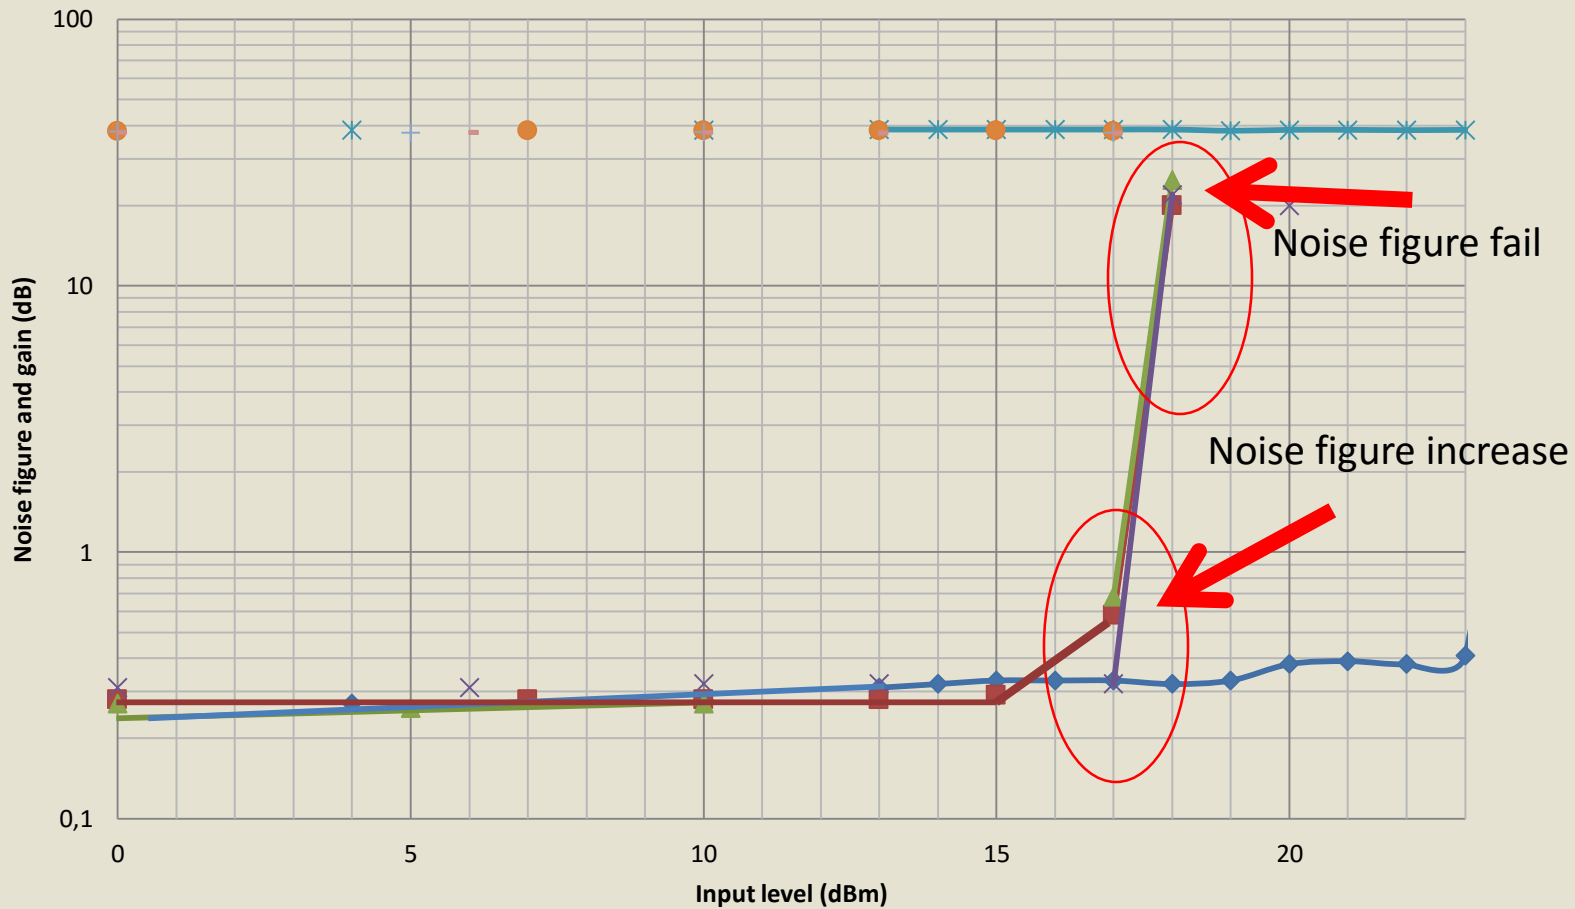
Early results - Power on Table 1,2,3,&4

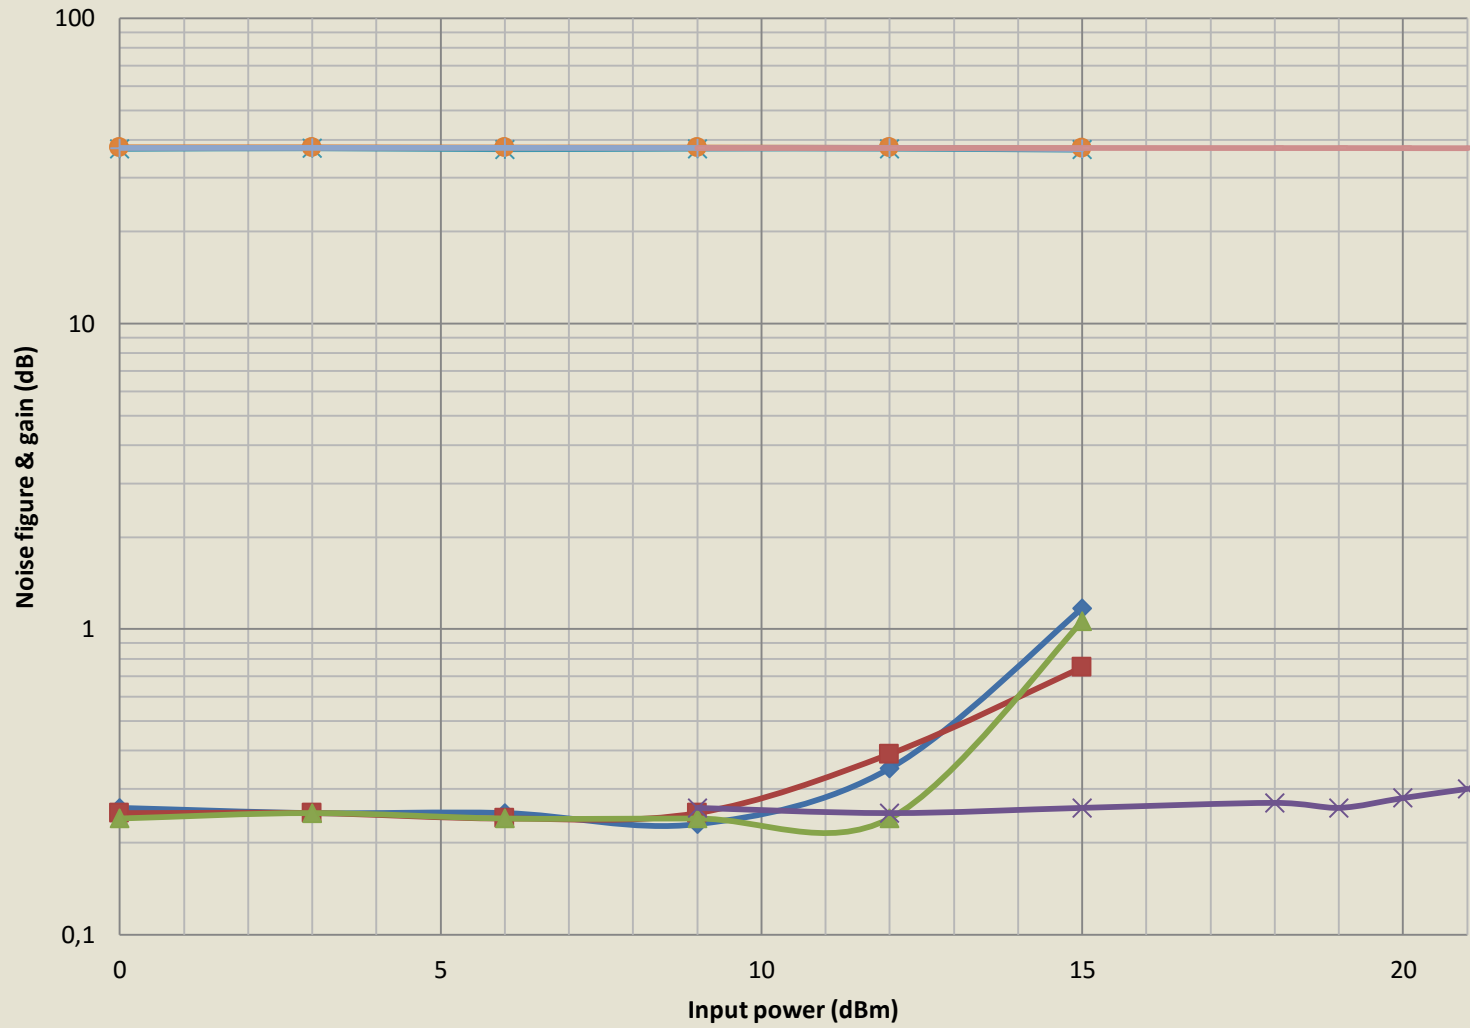
Latest results - Power ON

- Occurs mainly between +12dBm and +17dBm input
 - Anomaly due to gate puncturing?
- It seems to be due to the onset of gate current
 - Too low to be measured (maybe picoamps?)
 - At this level of gate current the gain is largely unaffected
- Most devices fail completely between +20dBm and +23dBm input

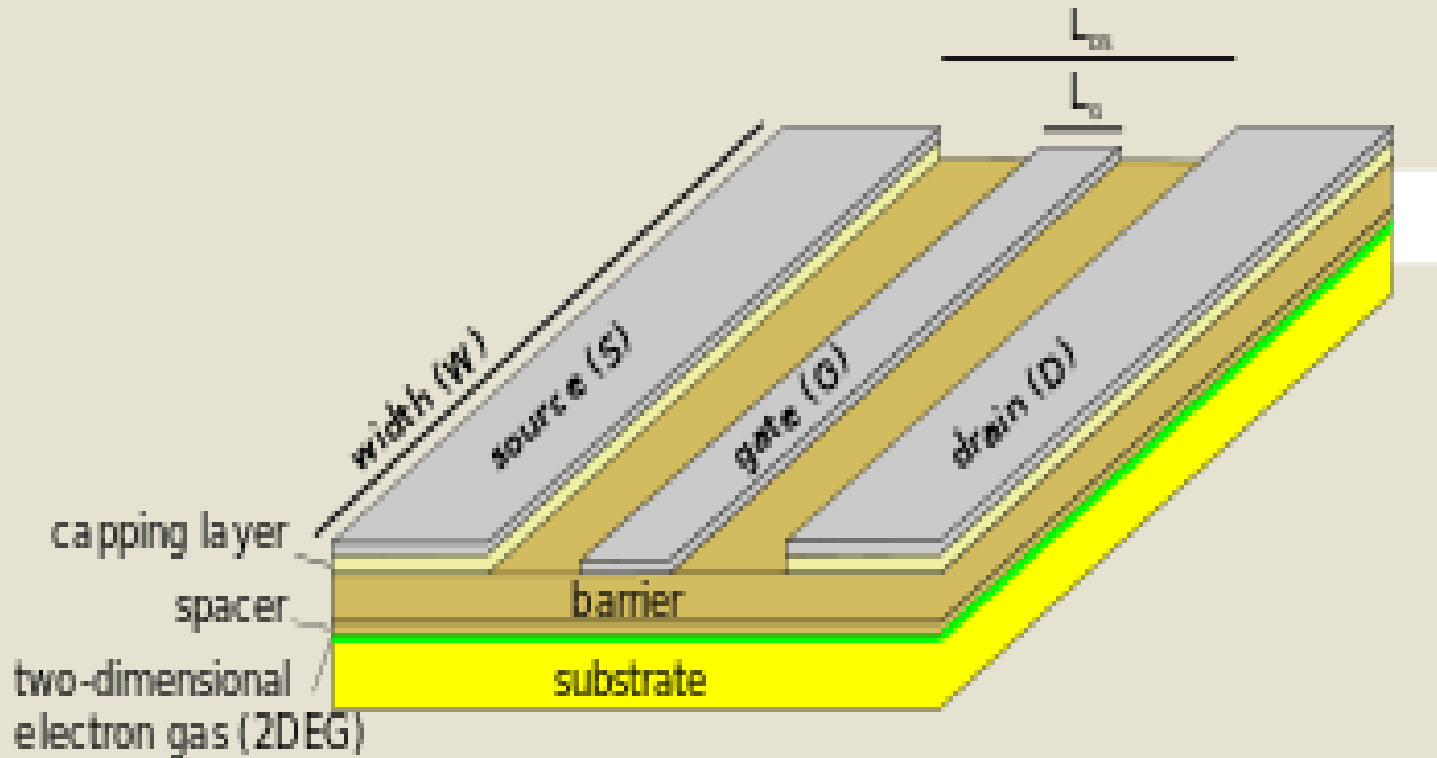
Basic HEMT structure
