Problems with the display at my TS 850

At our VHF/UHF QTH, the " Ahornberg" mountain, we are using a Kenwood TS 850 as the exciter for our 70cm station. Doing its job during summer with +30 degrees and winter by -25 degrees in our hut, we never had any problems with this radio since many years.

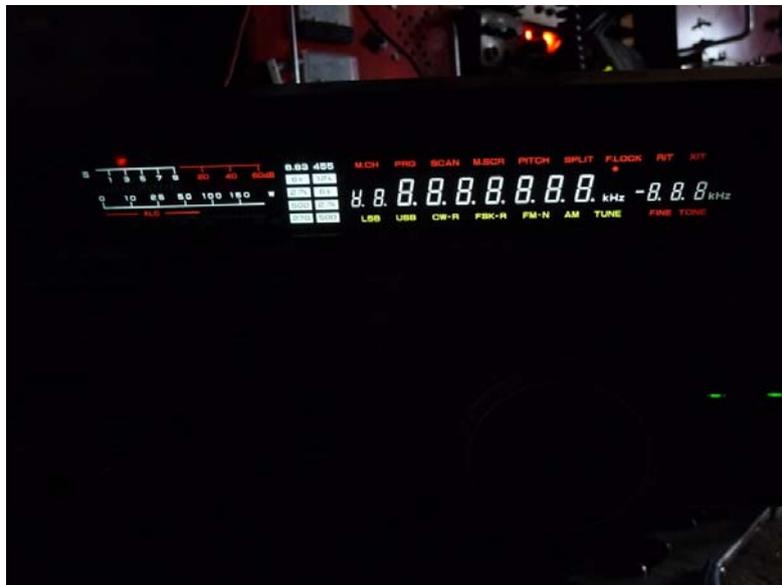
At the last weekend when I switched the TS 850 on, suddenly I could not read any more at the display. If I was pressing any switches or turning the frequency variation knob, the display was changing but it shows only nonsense.

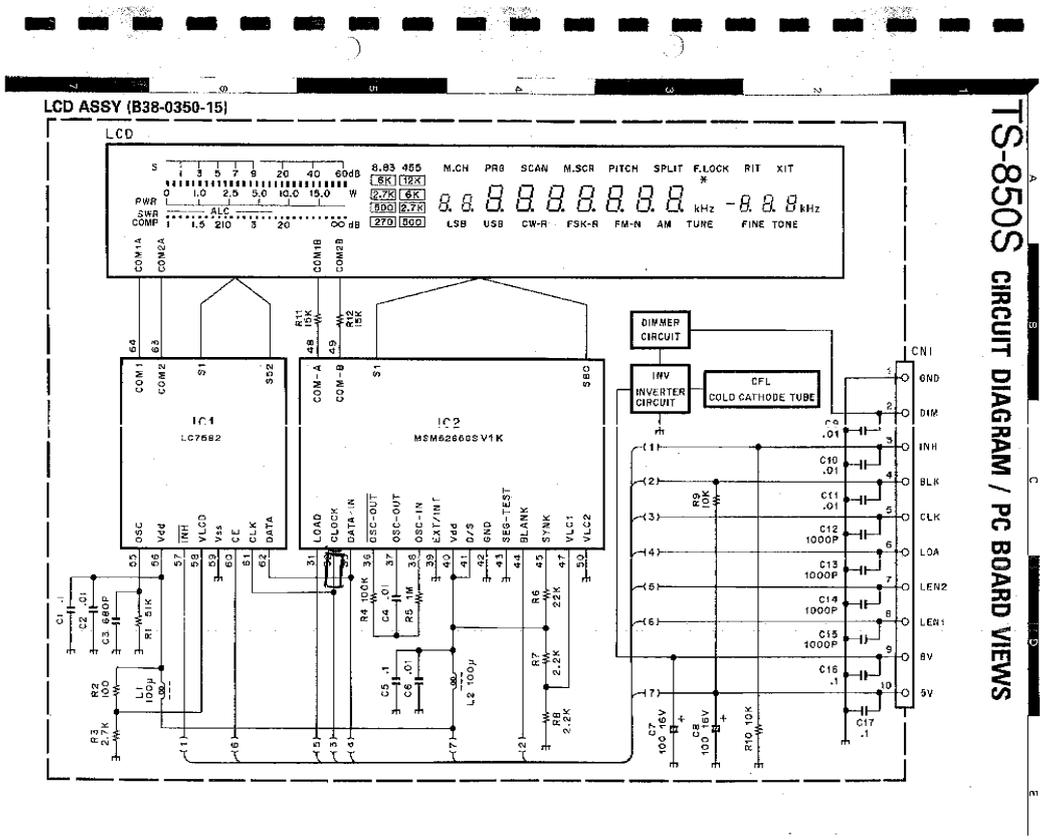
Spending lots of hours with reading the diagram and the service handbook I recognized a missing "clock" signal at the pin 32 from the 2nd display controller. It is marked as IC 2 at the LCD assembly.

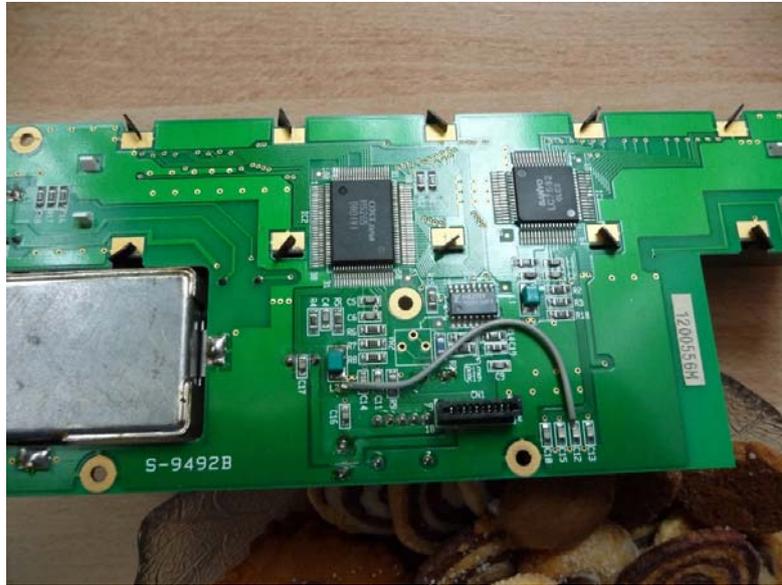
The problem was a destroyed contact between the front- and the back of the PCB (sorry for my poor English, I do not know the special word). I could remove this problem very simple when I was bypassing the missing contact with a piece of wire.

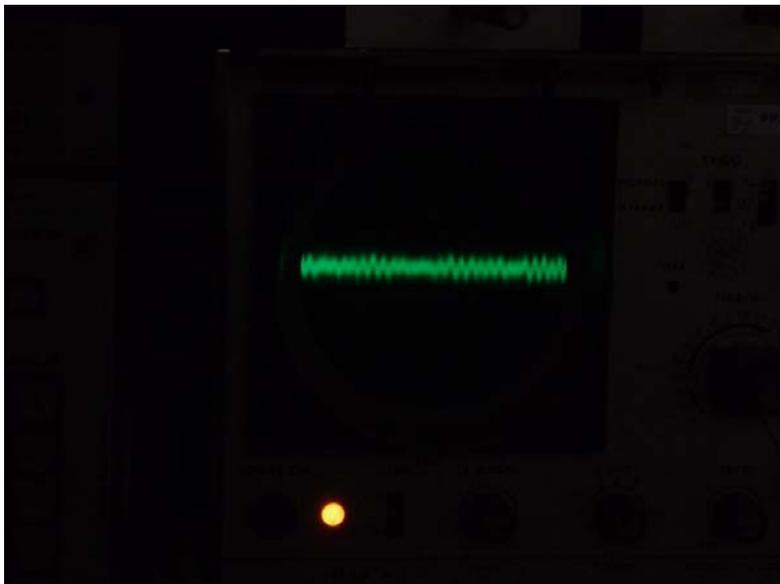
The next picture shows (?) the "clock" signal at pin 32 of IC2. I am very sorry that I have only an oscilloscope from Phillips which is 50 years old and it is not able to give a better picture! Is there somebody who has a newer one for a good price for me?

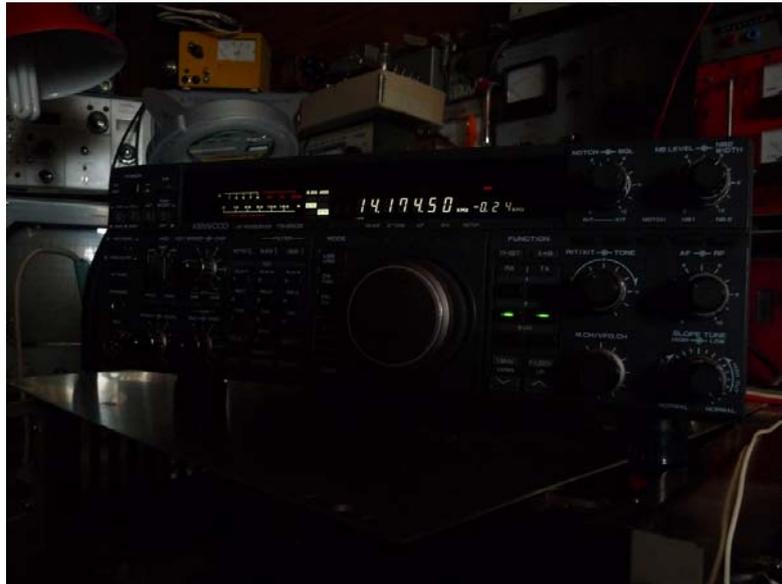
The last picture shows the TS 850 with the correct display after repairing.
